## SERVICE INFORMATION

**ST-012-06**

**SUBJECT:** Defrost Control 031-01975-000 (S1-03101975000) SAP#10211

**UNITS:** BAUP-\*042, BAUZ-\*042

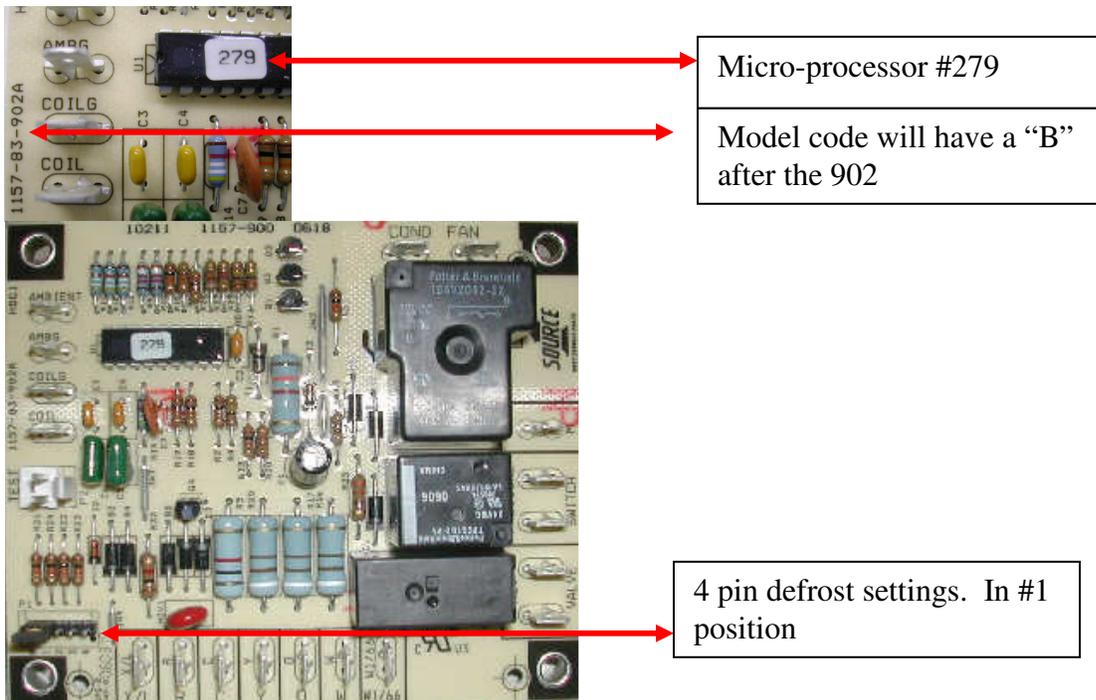
The New version of the S1-03101975000 board with the revised service Pin #4 is designated as a "B" version. Unfortunately the vendor failed to change the code to a "B" on the first shipment of new boards. However, the micro-processor was changed and will have a #279 label.
