SERVICE INFORMATION

YS-037-06

Subject: YMA048 & YMA060 Unit Nuisance Heat Pump Trips During Defrost

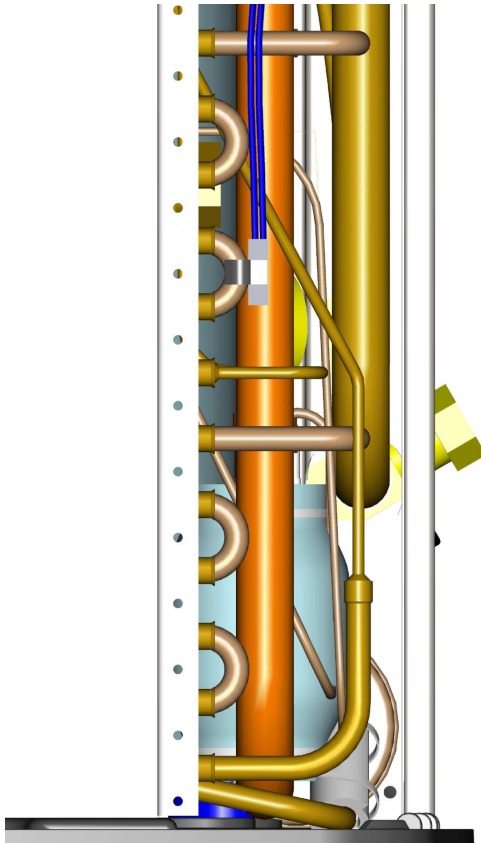
Fig 1: YMA048, HL2A048, HC2A048

As a result of some Product Reports submitted about units tripping on high pressure before exiting defrost laboratory testing was performed on YMA048 AND YMA060 units, which has resulted in the following:

If a unit is found to trip the high pressure switch before exiting defrost the liquid line sensor can be relocated to the attached location: **Note figures one and two show where to relocate the liquid line sensor on the YMA048 units. Figures three and four shows where to relocate the sensor on the YMA060 units.**
